REFRACTORY REPAIRS

<u></u>	I					
Approved By: M. Whatley	Revised By: H. Whatley	Drawn By: S. Fertitta	Drawing No: T2B001-REFRAC	TRANS. TO BOILER REPAIR	Drawing Name:	
Date Approved: 12/22/2019	Date Revised: 12/22/2019	Date Drawn: 12/12/2019	REACTOR 4	INEOS	Project:	
Sht: 1/6	Rev: 0	Scale: N/A		INEOS Nitriles		M

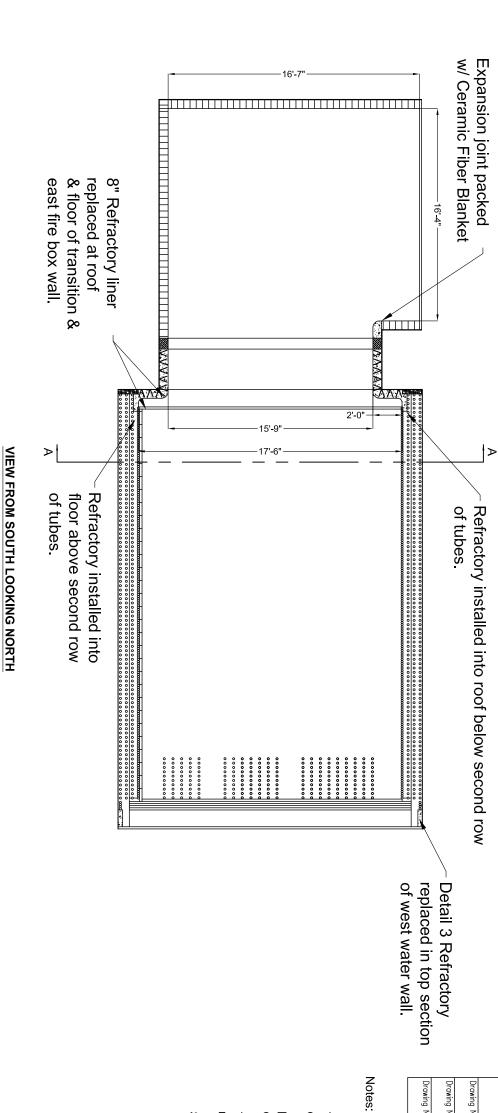
VIEW FROM TOP LOOKING DOWN

This drawing is showing the refractory that was installed in order to make repairs.

at expansion joint of transition.

over new plate in Modules installed

east side of fire box

Modules 100% replaced

8" Refractory liner

behind new place in Refractory installed

replaced at north

& south side walls of transition & east

fire box wall.

repair at east wall. fire box & behind skin
