069E-201 (#1 SRU) WASTE HEAT RECLAIMER
VIEWING NORTH SIDE VIEW

JOB TITLE:
#1 SRU BRICK REPAIR IDENTIFY

EQUIPMENT ID: 069E-201	UNIT: EXCHANGER
DWG No. RCS-0120735-SRU1	PROJECT: BSR-PWTA 2020
DRAWN BY: H. WHATLEY	DATE: 01/26/2020
REVISD BY: N/A	DATE: -
CHECKED BY: M. WHATLEY	DATE: 01/26/2020
APPROVED BY: M. WHATLEY	DATE: 01/26/2020
SCALE: N/A	REV: A
SIZE: D - 11x17	SHEET: 1 OF 1

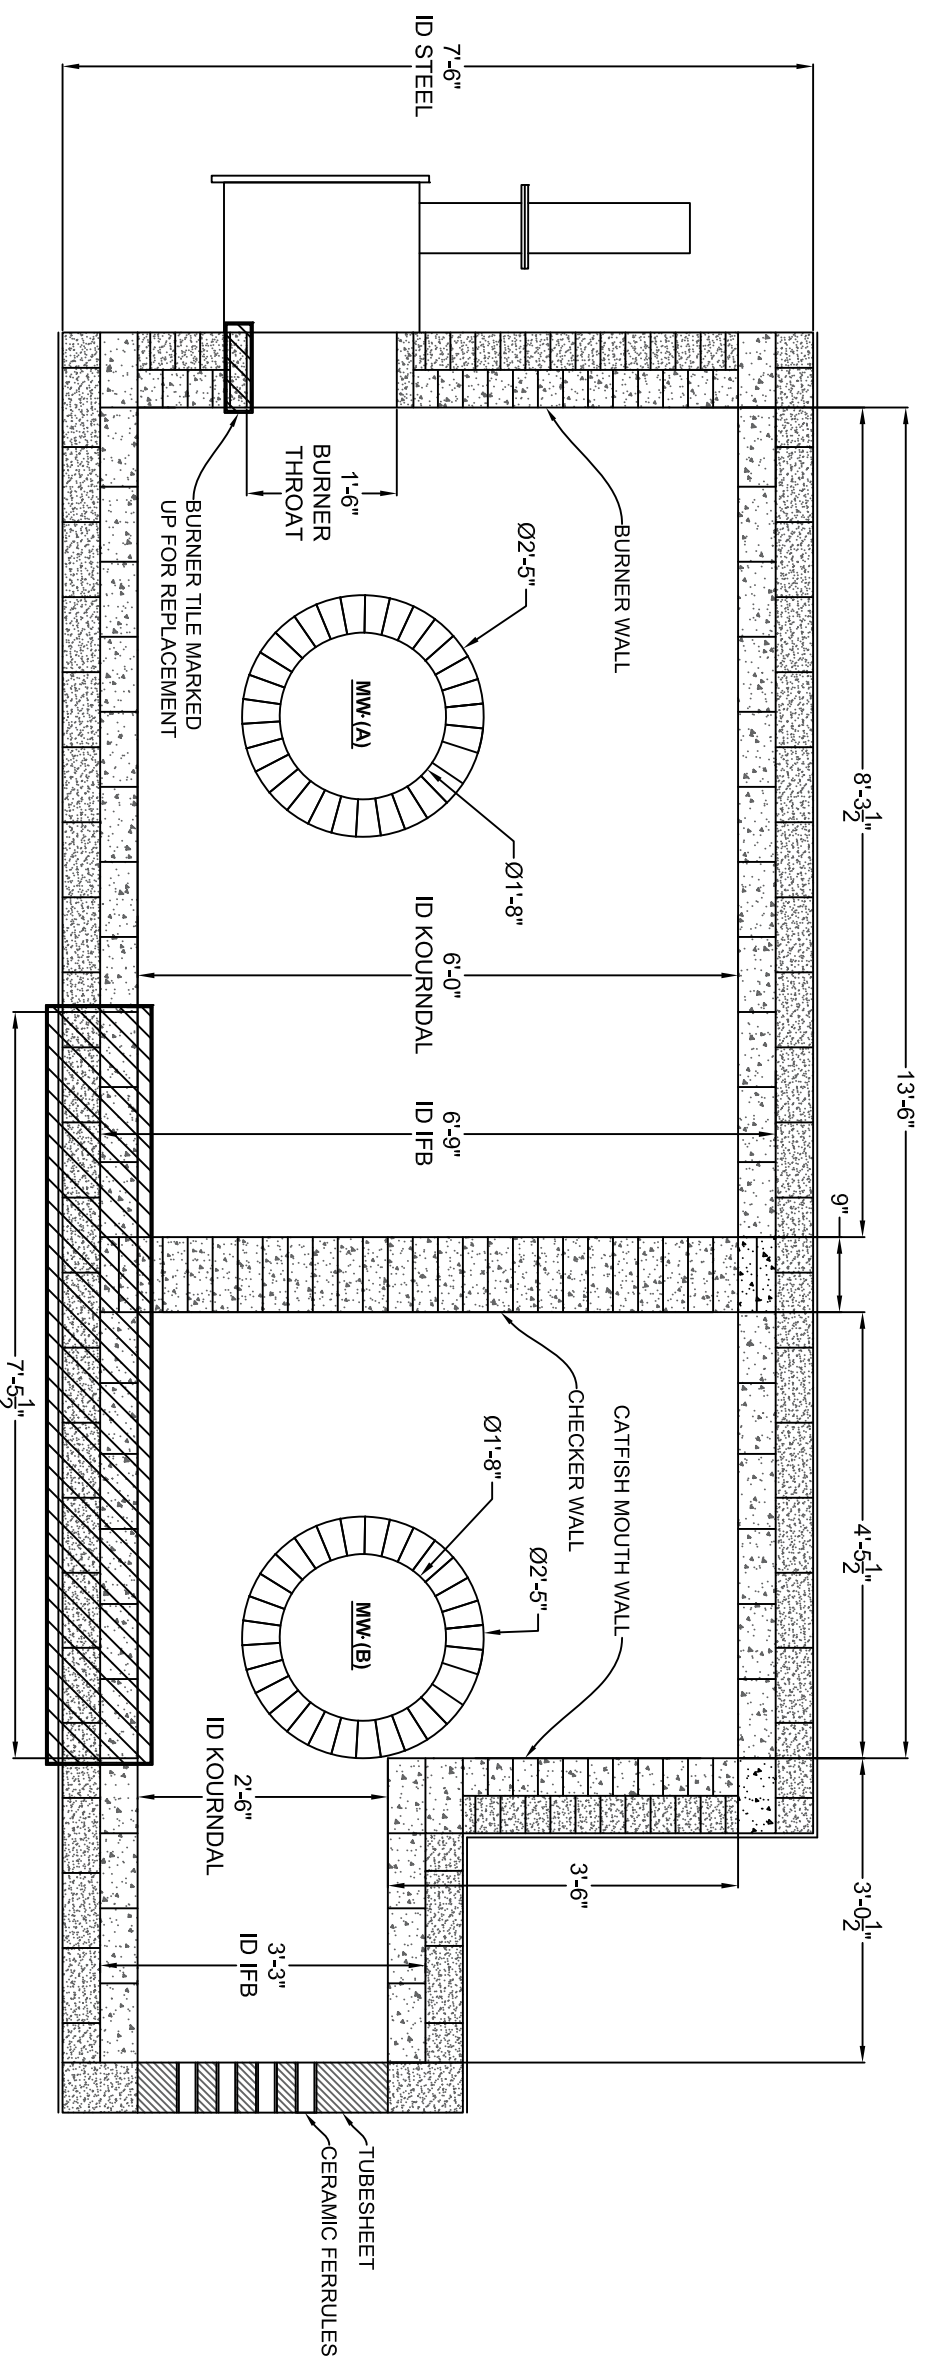
(10) COURSES W/ CHECKER WALL OF BRICK ARE LINED WITH THE MARKINGS FROM UNDERNEATH SRU BY MECHANICAL WHERE SKIN REPAIRS ARE TO BE MADE.
